# Evaluation of the Patient with Hip Pain

Ted Parks, MD

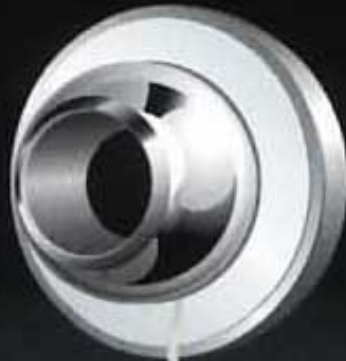
**Wear  
Rate**  
(microns/year)

**CoCr/Polyethylene**

**200 microns/year**

**CoCr/Crossfire<sup>®</sup>  
Polyethylene**

**20 microns/year**

**Metal/Metal**

**4.3 microns/year**

**Alumina/Alumina**

**<1 micron/year**

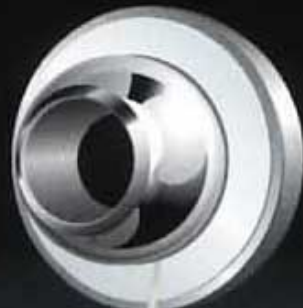
**Wear  
Rate**  
(microns/year)

**CoCr/Polyethylene**

200 microns/year

**CoCr/Crossfire<sup>®</sup>  
Polyethylene**

20 microns/year

**Metal/Metal**

4.3 microns/year

**Alumina/Alumina**

<1 micron/year

**Alumina/X3<sup>™</sup>**

1.4 micron/year
